REPORT ON USATECOM PROJECT NO. 8-3-0030-06F  
PRODUCT IMPROVEMENT TEST OF BOLT ASSIST DEVICES  
FOR RIFLE, CALIBER .223, AR15  
REPORT NO. DPS-1120  
NOVEMBER 1963

U. S. ARMY  
DEVELOPMENT AND PROOF SERVICES

Three models of charging handle bolt assist devices for the caliber .223 AR15 rifle were evaluated for effectiveness in manual extraction and bolt closure operations. A plunger-type bolt closure device was also evaluated. The devices were tested for operation under various adverse conditions, and other special tests were also conducted. Only the plunger-type bolt closing device provided an effective means for closing the bolt under adverse conditions. The modified charging handle did not provide adequate means for extraction operations under adverse conditions. It is recommended that the charging handle bolt assist device tested not be adopted.

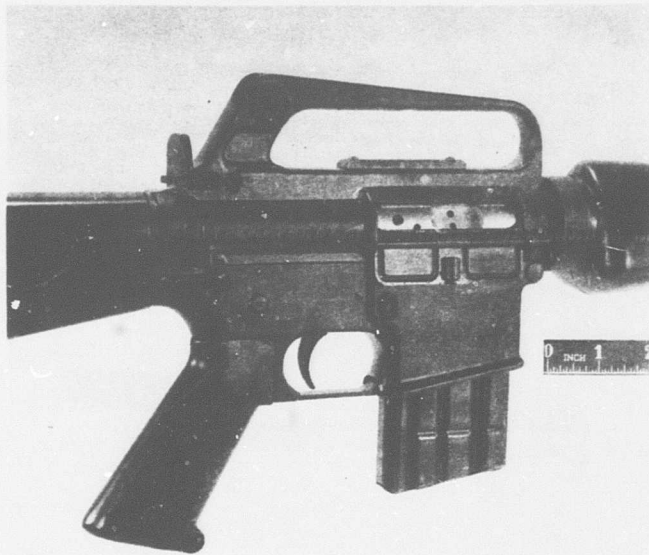
- c. The receiver was modified by removal of material from the area under the carrying handle to accommodate a riveted steel cam plate. An external view of the cam plate is shown in Figure 5. The rifles provided with double latch charging handles had a notch cut into the right side of the receiver to accommodate the additional latch.

**Figure 5: Modified AR15 Rifle. Note Riveted Cam Plate under Carrying Handle and Double Latch Charging Handle with Contact Pad at Rear End to Assist in Bolt Closing and Opening Operations.**

- b. The modified charging handle bolt assist device served as an aid in closure of the bolt under some conditions, but the device did not always position the bolt carrier sufficiently forward to permit firing to take place. In addition, on several occasions when pushing the charging handle forward, a bullet stubbed the magazine causing the charging handle to disengage from the bolt-carrier key plunger (ref pars. 2.2.3, 2.3.3, and 2.4.3).

It is recommended that the charging handle bolt assist device tested not be adopted.

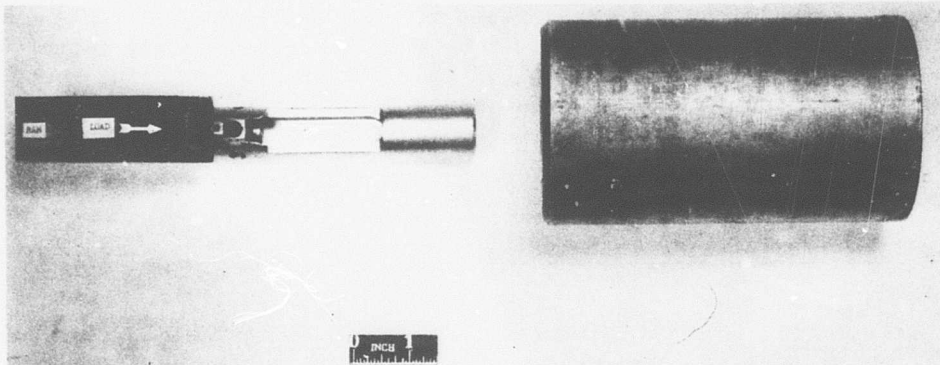
- a. Two early model bolt carrier key plungers failed in shear at loads of 435 and 445 pounds; two of the latest plungers failed at loads of 235 and 240 pounds.
- b. Two charging handle spring tabs failed in tension under loads of 1230 and 1310 pounds.
- c. Each of two double-latch charging handles was subjected to a load of 1650 pounds without failure or disengagement of the latches occurring.

Figure 14: Test Fixtures for Shear Test of Bolt Carrier Key Plunger. Plunger Contact Area of Ram Was Shaped to Radius and Thickness of That of Charging Handle Spring.

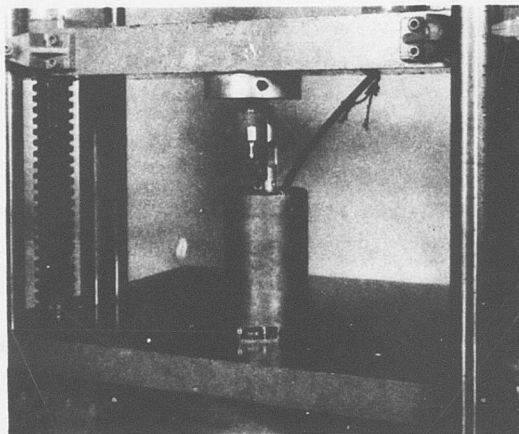
Figure 15: Bolt Carrier Key Plunger Undergoing Shear Test.

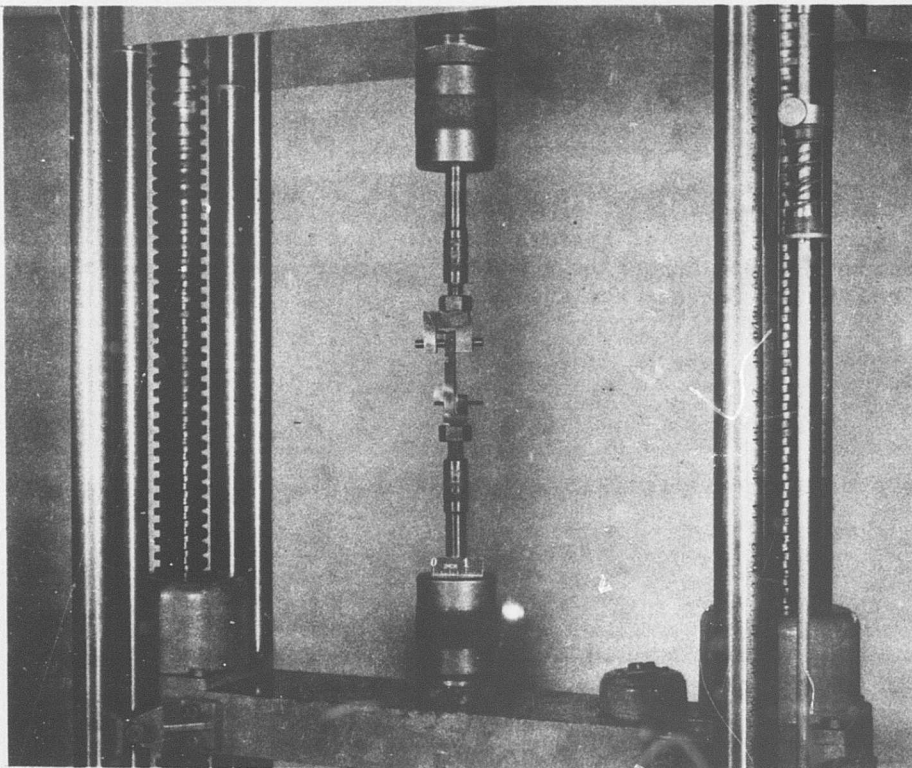
Figure 17: Testing Machine Setup for Tensile Test of Charging Handle Spring.

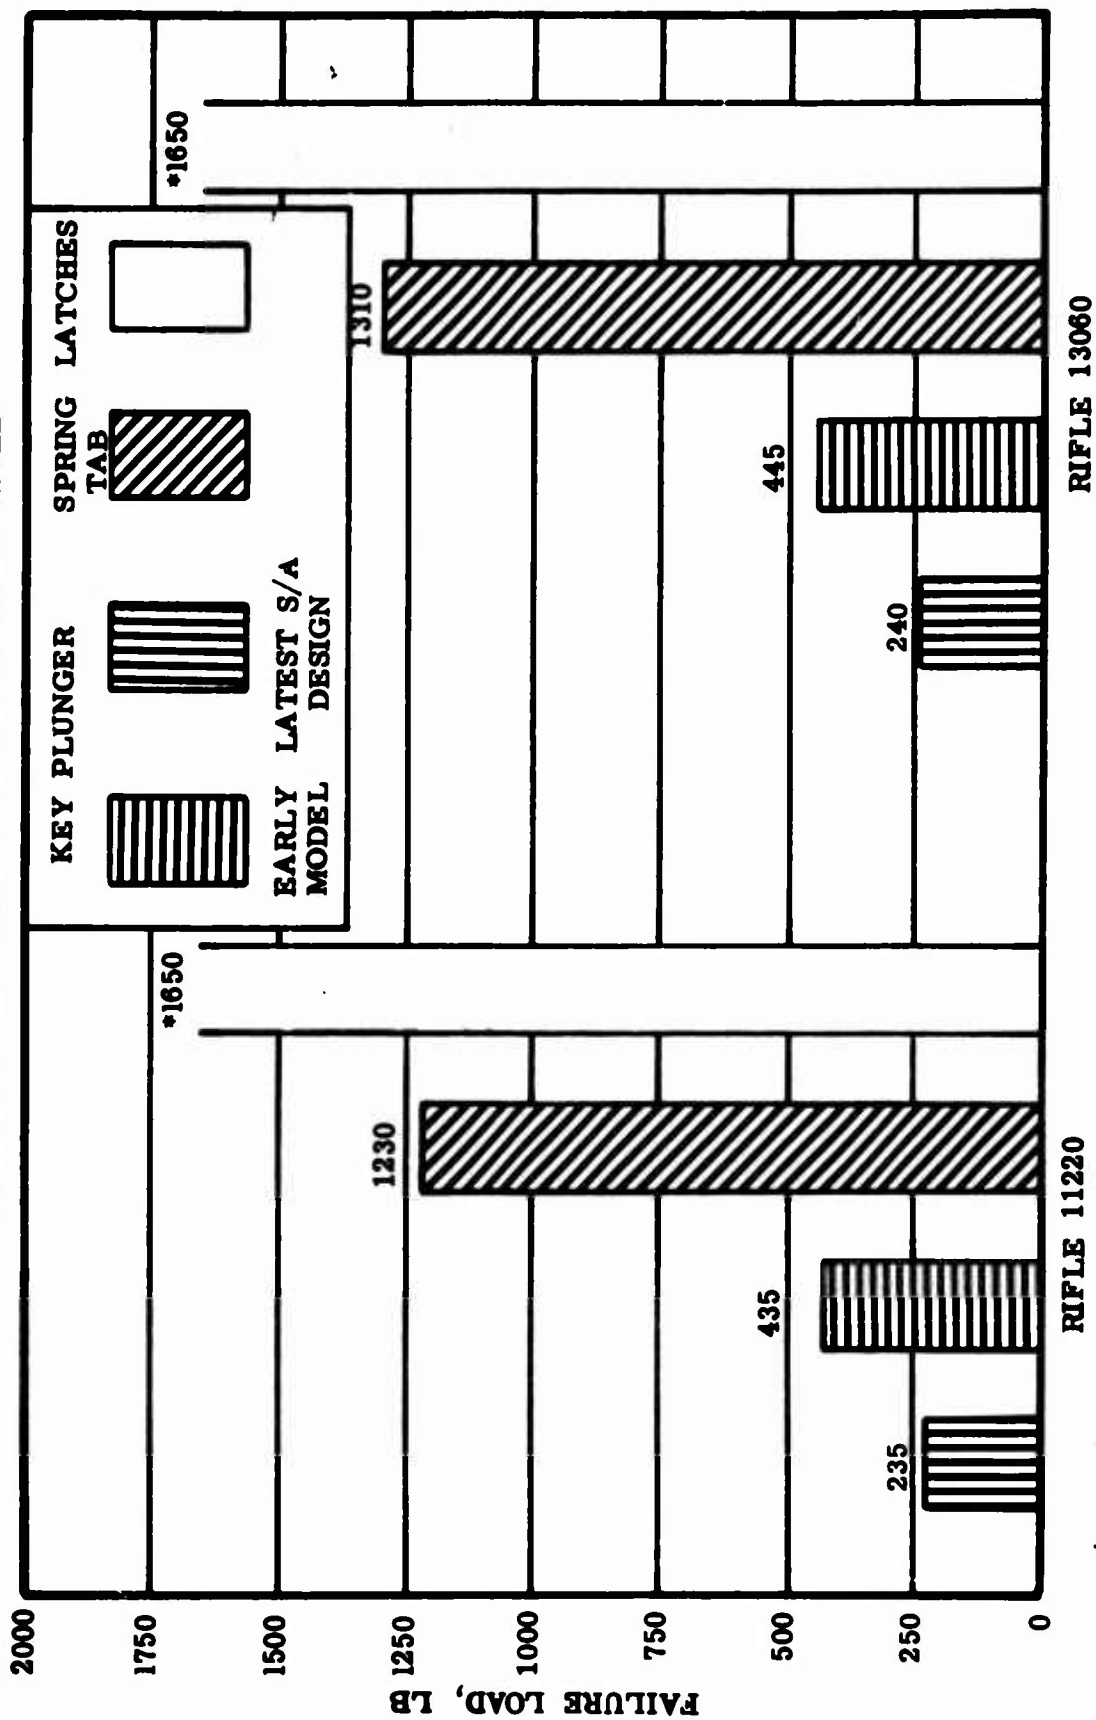
Figure 20: Test of Bolt Assist Device for AR15 Rifle.

2.6.3 Discussion. The destructive tests revealed that, in the event the charging handle spring is engaged with the carrier key plunger at the time of firing and the charging handle latches are engaged, the carrier key plunger will fail before the charging handle spring will fail, and the spring will fail before disengagement or failure of the charging handle latches will occur.
